Application Report No. A 30-2e **Decoating a Collection Basin Under Storage Tanks**

PIOMAR, Poland

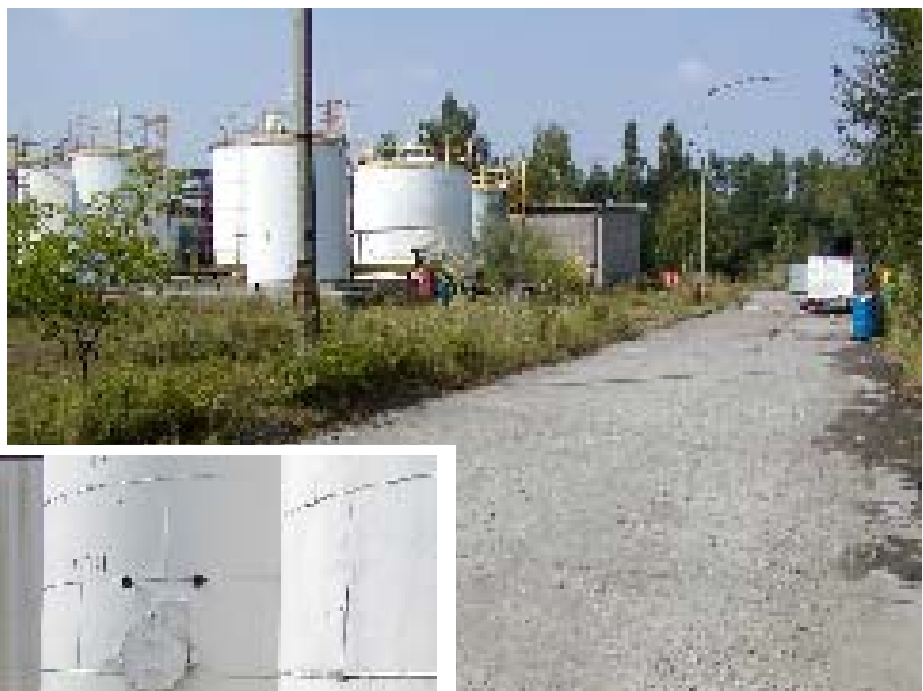
In a tank farm in Poland it was necessary to remove the coating on a collection basin underneath storage tanks. At the same time, the subsurface (concrete and brickwork) had to be prepared for a subsequent coating which is resistant to oil and moisture. After treatment, the adhesive strength of the subsurface was not less than 1.5 N / mm².

The job was done using an Orbital Nozzle, at a working pressure of 1000 - 1100 bar.

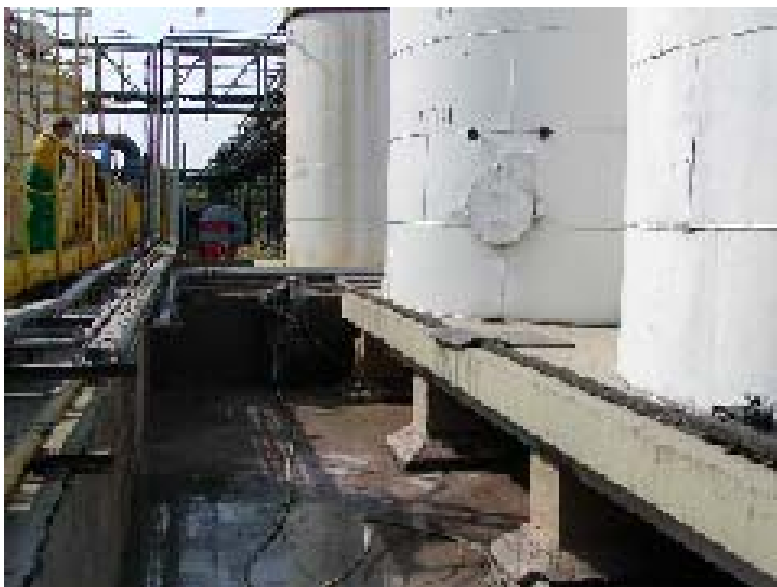
Photo on the right:

Both the old plaster layer and the old coating were removed from the brickwork foundation

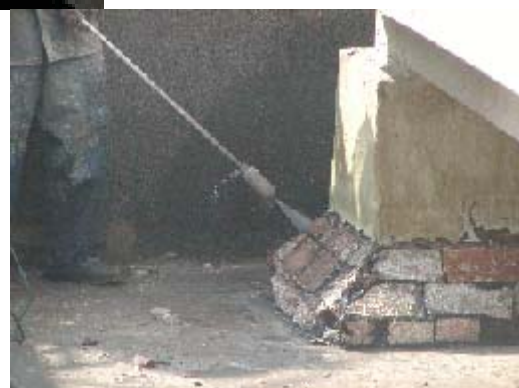
Treated surface
Untreated surface

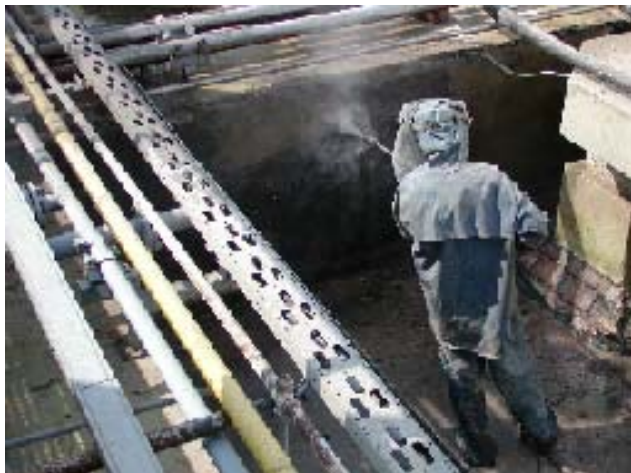
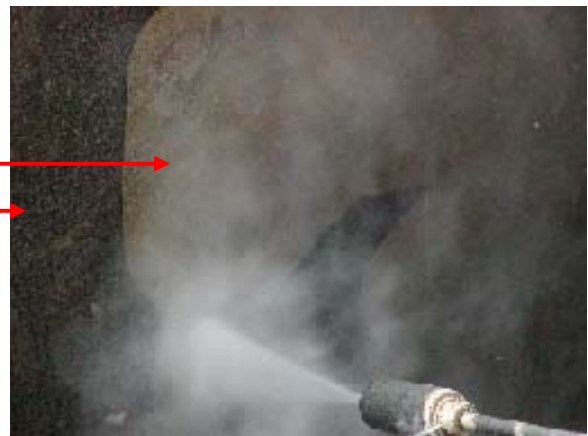
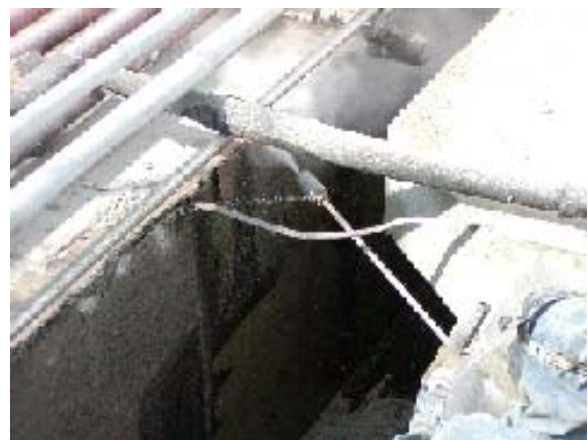
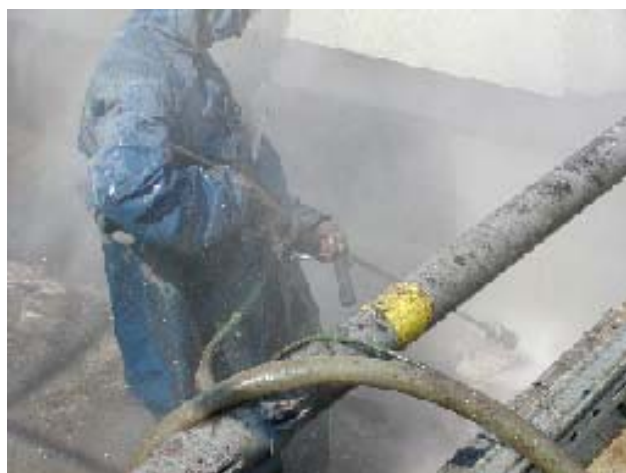
The photos on this page show how the work was carried out using a high pressure gun KSP 1200 and an Orbital Nozzle.

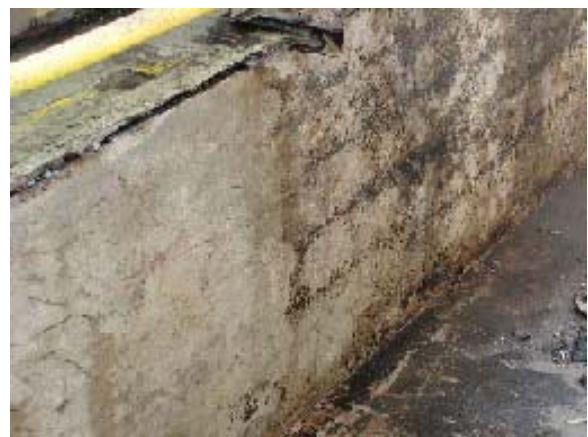
Photo above:
After treatment, the roughened and cleaned concrete is clearly visible. This surface is ideal for applying a new coating.
