Application Report No. A 01-2e **Evaporator Cleaning in the Food Industry**

PIOMAR, Poland

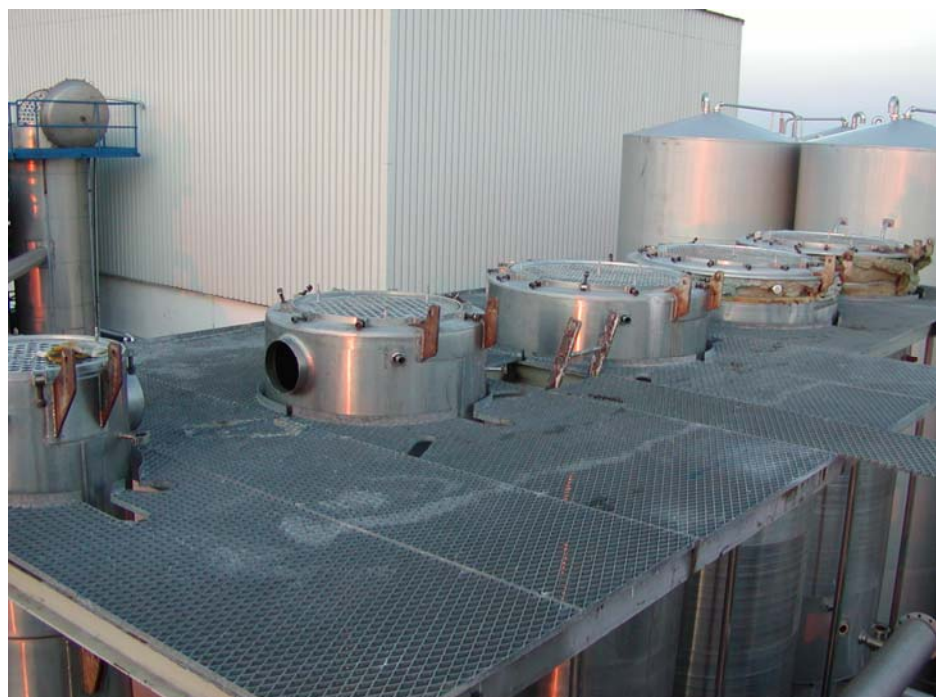
Photo on the right:

View of a work platform with five evaporators in an open position

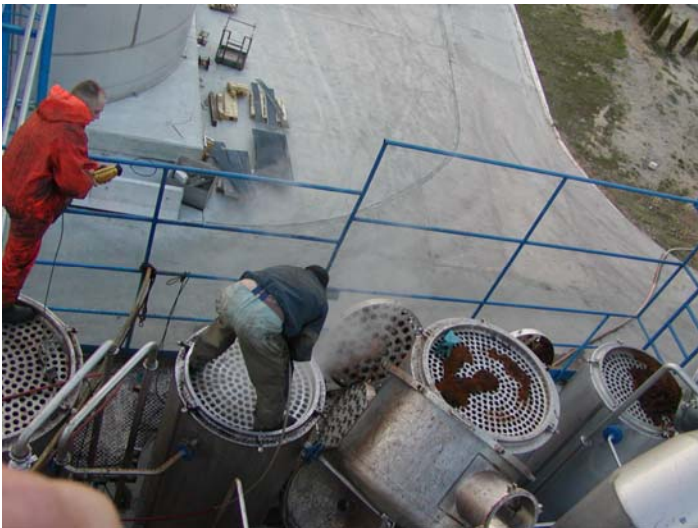
Photo on the left:

Cleaning an evaporator. The opened-up evaporator on the right clearly shows the external contamination.

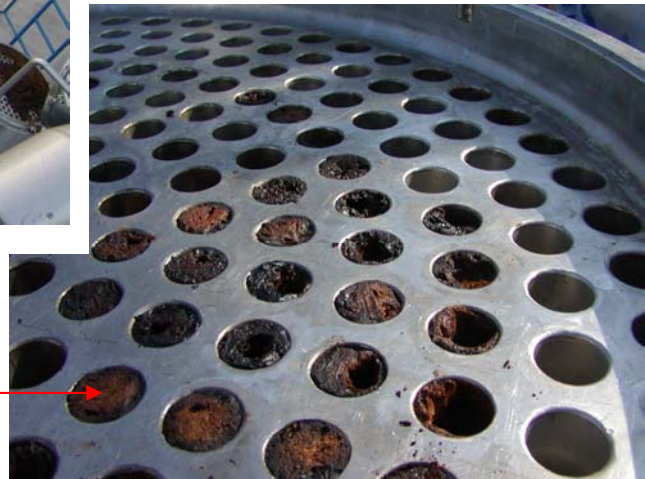
Photo on the right:

The tubes of the evaporators become blocked in the course of some months. When they are fully blocked, the production comes to a standstill.

Tubes which are completely blocked.

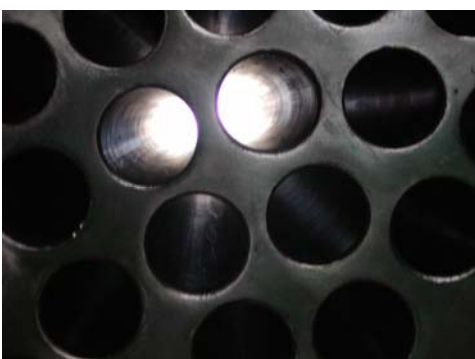
Left:

Cleaned tubes of the evaporator

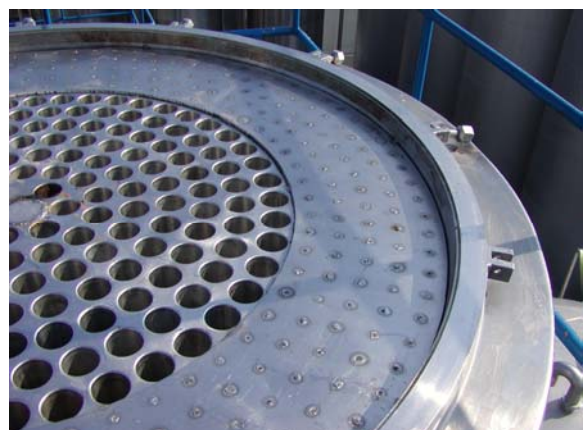
Right:

Evaporator after cleaning
