Application Report No. A 12-1e

Removal of Coatings and Old Paint Layers from Building

HWT, Singapore

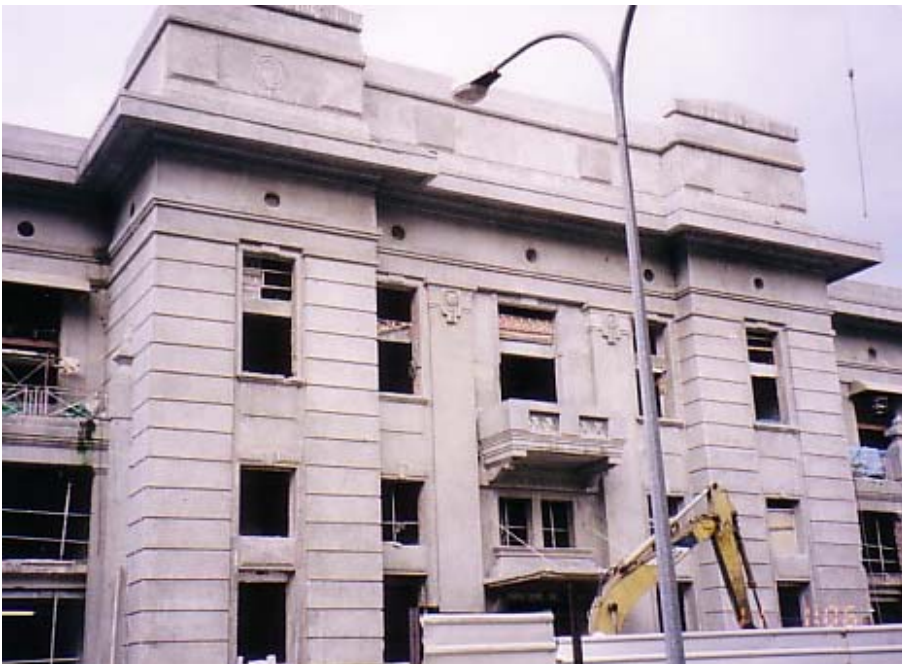
Photo on the right :

The work was carried out with KAMAT machines

Performance:

Working pressure: **2.500 bar**
Capacity **23 l/min**

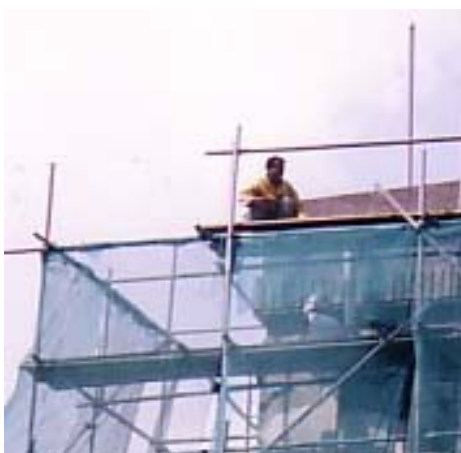
Photo on the left:

Service technician working from the scaffolding.

He is using a KAMAT **"Roto-Lance"**.

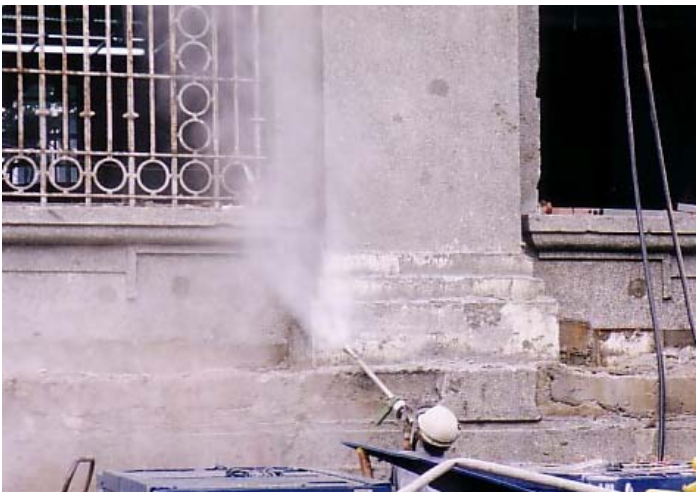
Photo on left:

The **"Roto-Lance"** in operation. Formerly, jobs of this nature could only be successfully carried out by the sandblasting method.

But this method is now prohibited in residential areas, due to the high rate of dust formation.

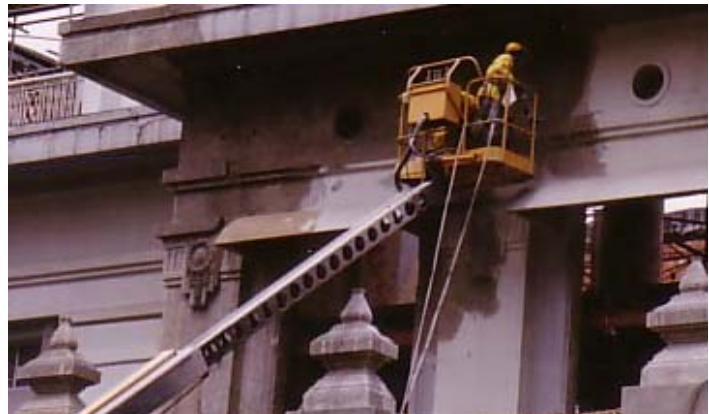
Photo on the right:

Wherever scaffolding was not practicable, hydraulic platforms were used.

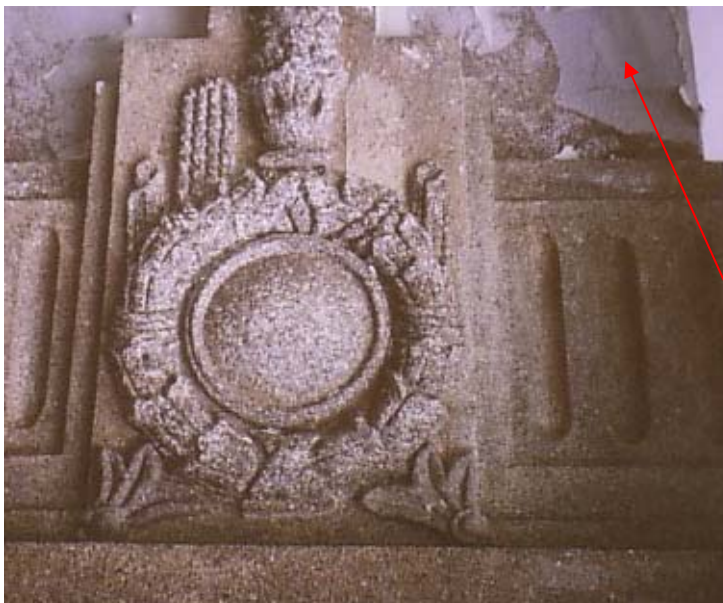
Photo on the left:

All coatings and paint layers were successfully removed from the stone ornaments, without causing any damage.

At the top of the picture the original coatings are still visible.
