Removal of Coatings and Old Paint Layers from Building

Our partner in Singapore, the company HWT, won a contract to remove old layers of paint and coatings from a building facade.

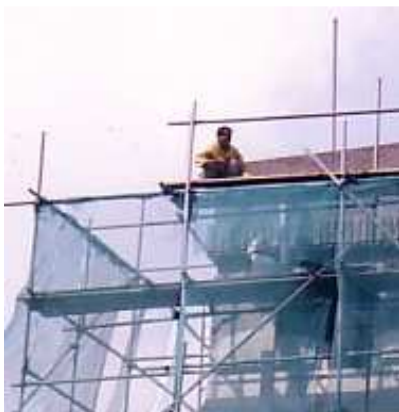
Photo on the right :

The work was carried out with KAMAT machines

Working pressure: **2.500 bar**
Capacity **23 l/min**

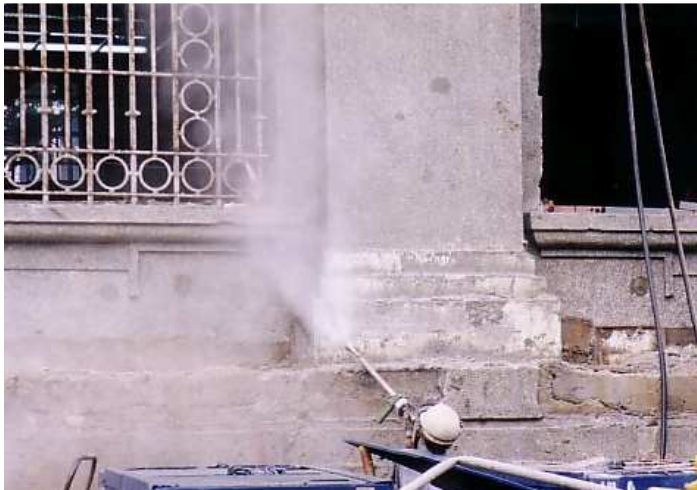
Photo on left:

The "**Roto-Lance**" in operation. Formerly, jobs of this nature could only be successfully carried out by the sandblasting method.

But this method is now prohibited in residential areas, due to the high rate of dust formation.

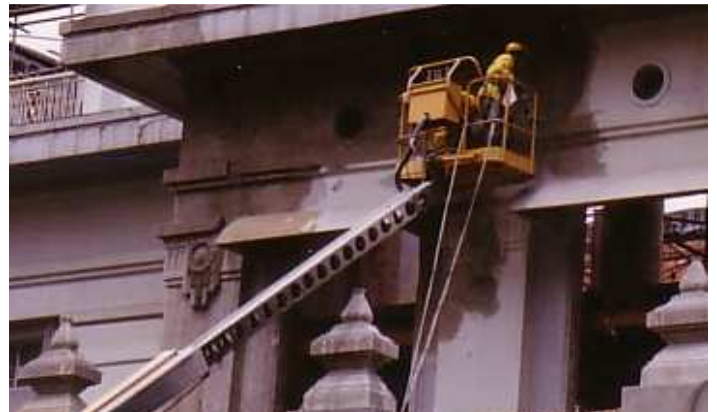
Photo on the right:

Wherever scaffolding was not practicable, hydraulic platforms were used.

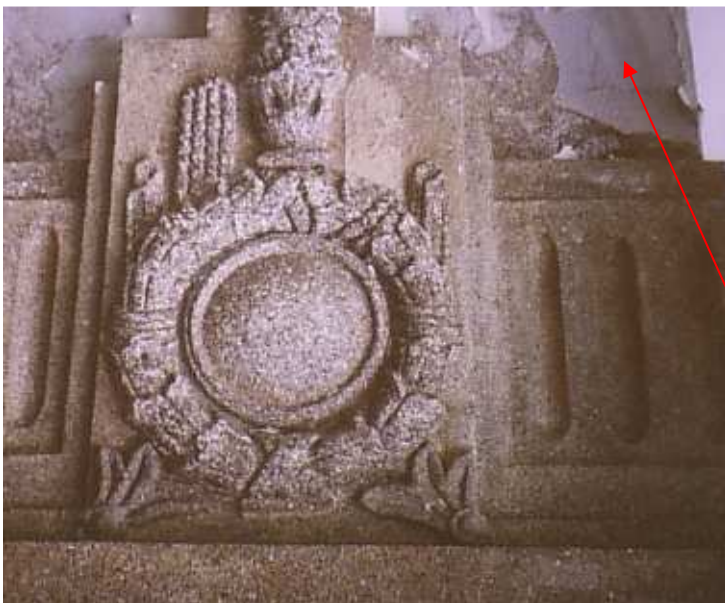
Photo on the left:

All coatings and paint layers were successfully removed from the stone ornaments, without causing any damage.

At the top of the picture the original coatings are still visible.
