Application Report No. A 04-5e
**Cleaning Parts of an Extruder in the
Polypropylene-Production Process**

In the course of the manufacturing process of polypropylene after a number of months there is a steady accumulation of deposits. One of our customers in Hungary carried out the job of cleaning an extruder, using a working pressure of 2500 bar.

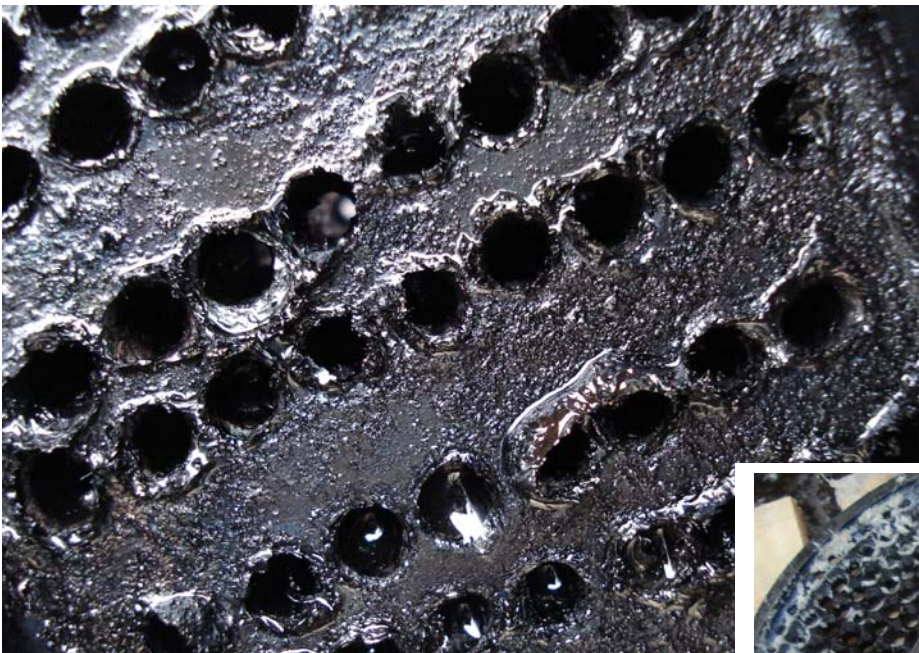
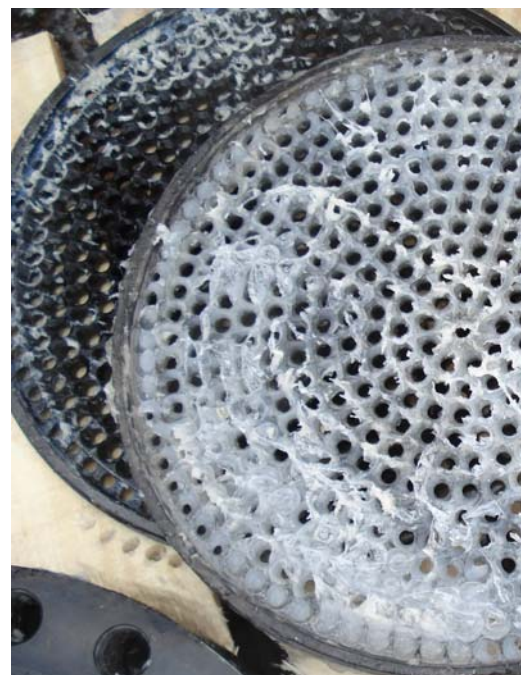
Pictures above and on the right:

The incrustations are difficult to remove and a working pressure of above 2000 bar is essential.

The equipment which was used for the job: A high pressure unit model KAMJET (performance 23 l/min at 2500 bar) plus a KAMAT gun type Roto-Lance.
