Removal of Coatings and Paint Layers from The Folds On Tin Roofs

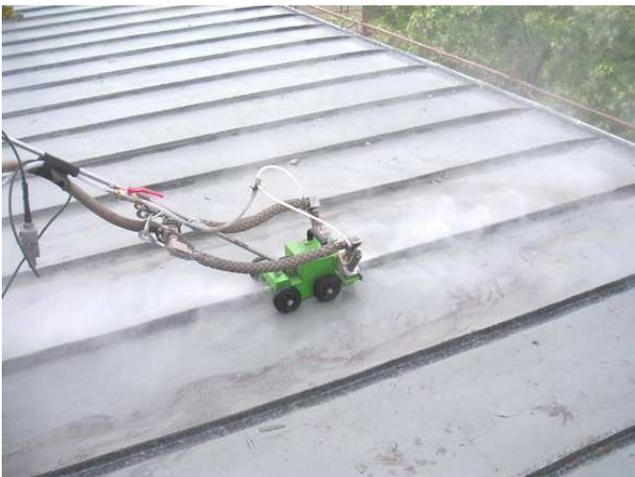
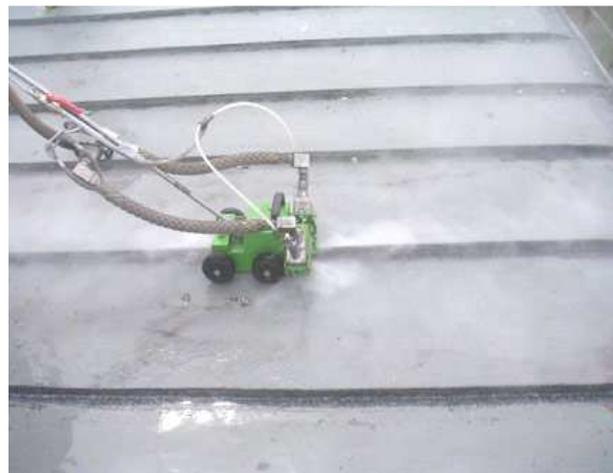
The KAMAT "Fold Cleaner FRG 2500" in operation at a construction site in Vienna, Austria

KAMAT constructed a special device called the Fold Cleaner "FRG 2500" and delivered the unit to the customer in Austria in January 2004. The mobile chassis is guided along the fold by means of skids at the front and rear and is equipped with two pieces of our "PRD 2500 air", each of which is fitted with a special nozzle head. The height of the unit is adjustable and the angle of the nozzle heads can also be varied.

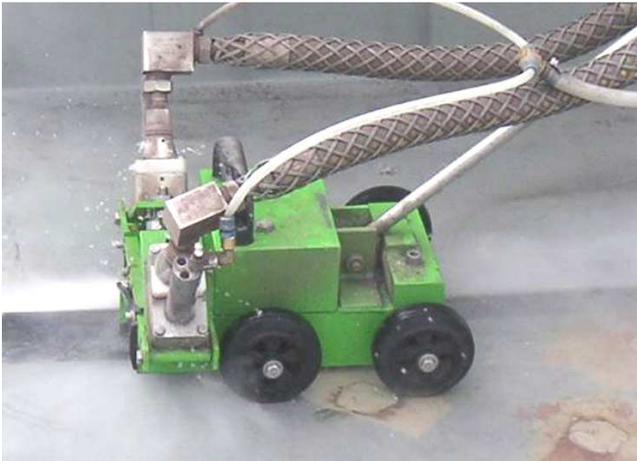
Fold Cleaner "FRG 2500"
in operation, driven by a
KAMJET 10000

Working pressure: 2000-2500 bar
Capacity: 23 l/min
Number of nozzles: 8 x 0.35mm

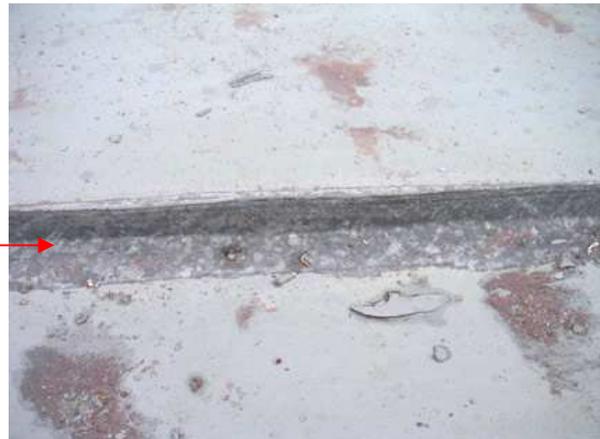
On the right side of the foto
the decoated joint and the
side strip can be seen
