Removal of an “Anti-Slip” Coating from the Runway of an Aircraft Carrier

Our Italian partner received a contract from the Navy, to remove a thick "Anti-Slip" coating from the runway of an aircraft carrier.

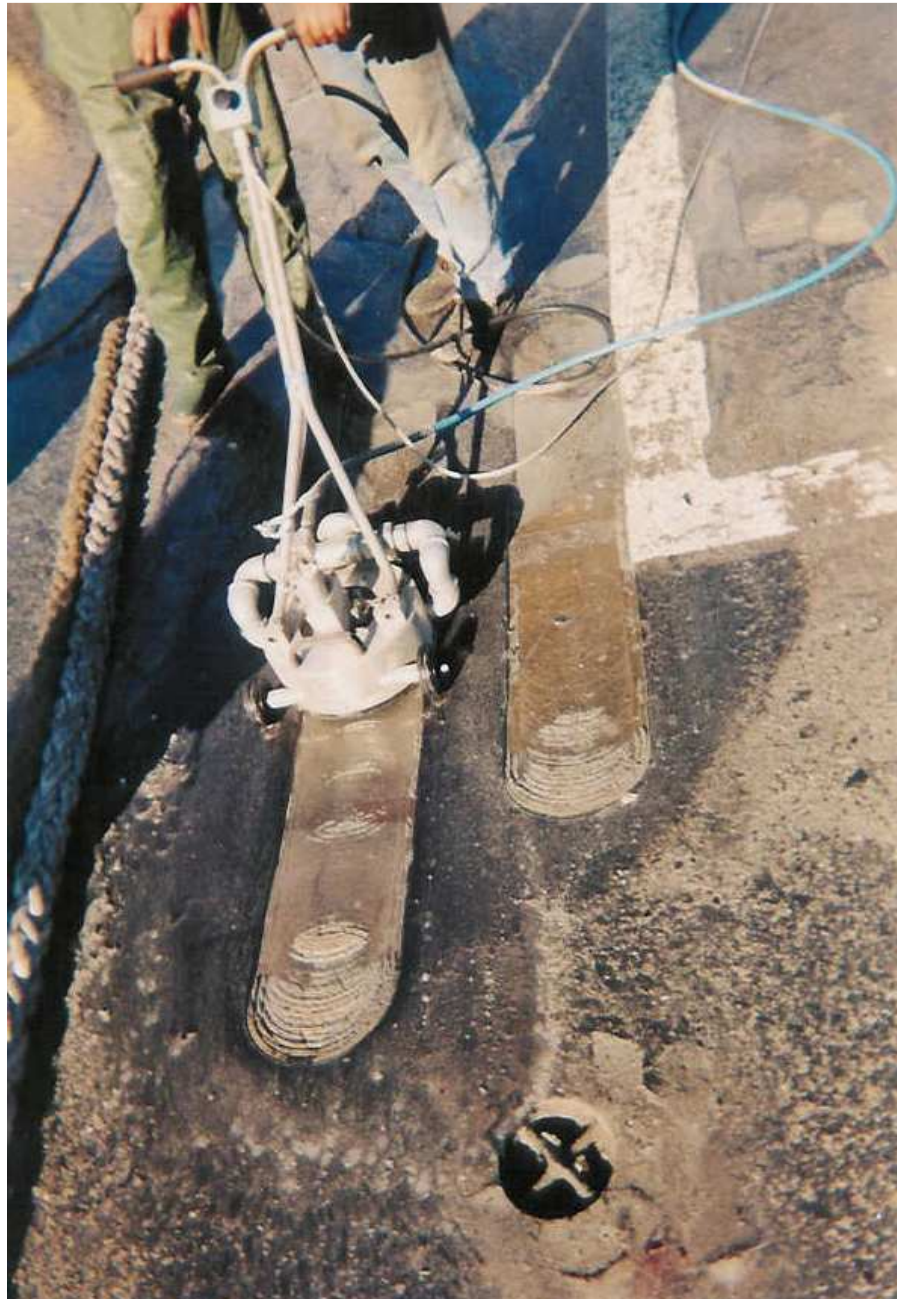
**“Surface cleaner”** in operation**Unit with pump K 10016**Photo above:

The horizontal surface of the runway was cleaned using a KAMAT "Surface Cleaner". The pneumatic drive ensured that an even and consistent surface finish was achieved.

The special coating is extremely thick (approx. 15 - 20 mm); for this reason a cleaning rate of not more than 12 - 16 m² / h was reached.

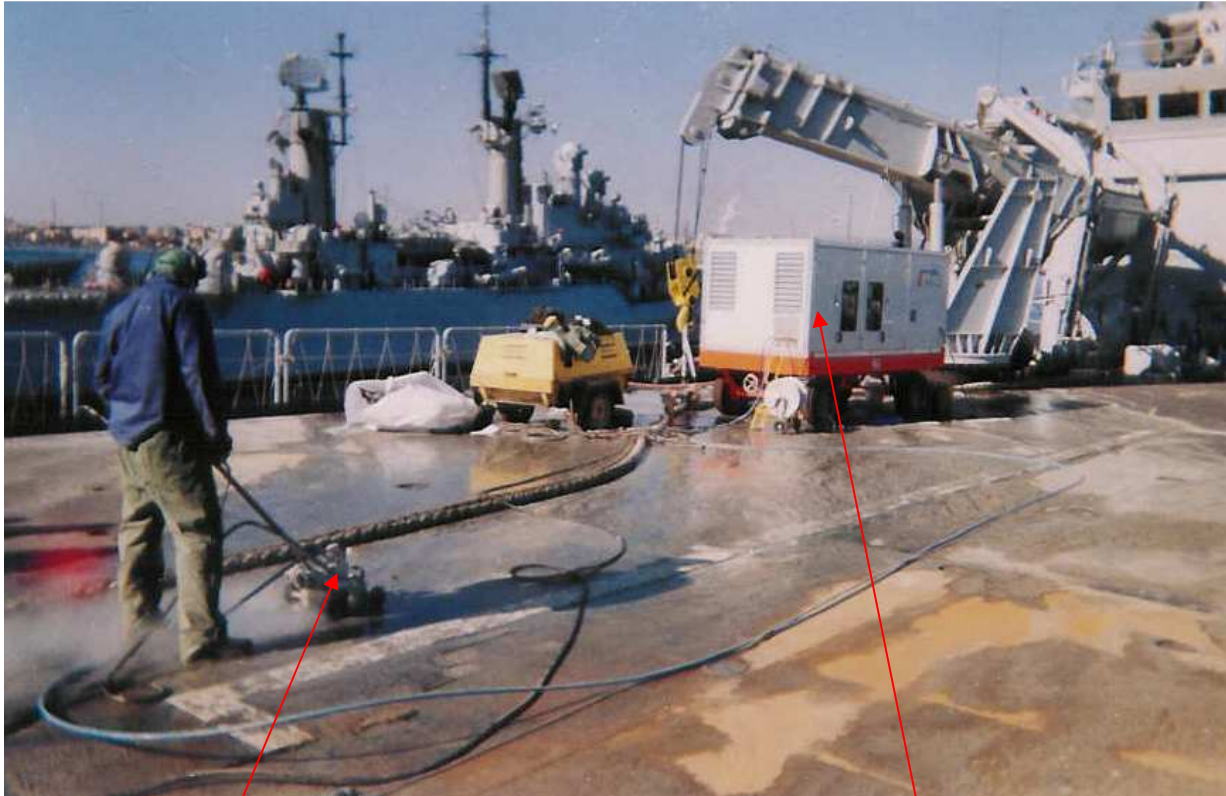
A PTC High Pressure Unit Type incorporating a pump **K 10016** was used for this job, with the following performance:

- p max. : 2500 bar
- Q : 23 l/min.
